Reconstructing the Brick Chapel of 1667

Honoring the Legacy

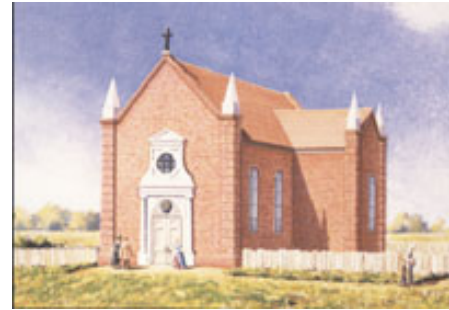
Archaeologists found a few traces of plaster that had been attached to wood lathe suggesting the ceiling was timber clad.

Fragments of window glass found at the site had been cut at different angles. These angles tell us the shape of the chapel windows.

Special mullion bricks were part of these windows. They were coated with a stucco-like material, which made them appear to be carved stone.

Flat roof tiles tell us that the roof had to be a steep angle or it would leak. Research has determined this angle is about 48°.

The width and depth of the foundation and comparisons with similar buildings suggest the chapel was about 25 feet tall.

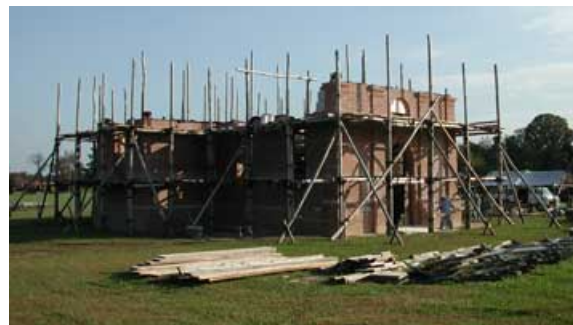
The front entablature, the section of the facade that rests on the columns, was completed in summer 2005. The entablature is about 4.5 feet in height. This area is a showcase for the masons' brick carving skills. The gracefully shaped bricks that comprise the entablature and highlight other architectural features lend elegance to the simple form of the chapel.

Most of the bricks for the entablature were carved over the winter of 2004-2005 and transported to the site. A few courses of carved brick top the side and back walls. Carved and coated kneelers, decorative corner elements that mark the beginnings of the gables, are in place on the north, west, and east walls. The front pediment of the church and the gables rise another 15 feet from this point.

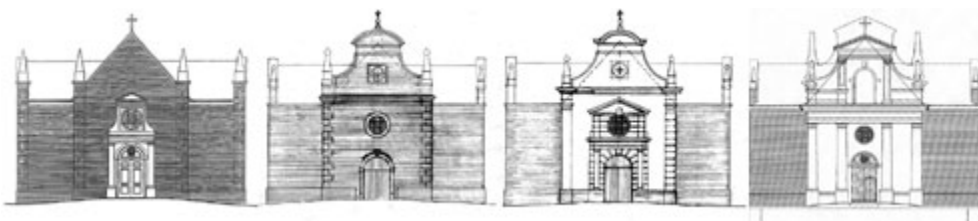
Plans for the chapel have evolved since the project was initiated. Through continued research, discussion, consolidation of ideas, and application of building techniques, various elements of several designs have been rejected and accepted. Thus, the building being erected is a scholarly best-guess as

to the likely appearance of the structure that stood here three centuries ago, taking into account the political, cultural, and economic realities in the colony and the backgrounds of the people who designed and built it.

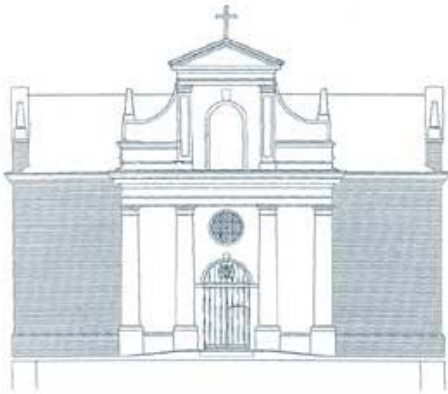
The plan calls for the front or main façade of the chapel to have a Jesuit- inspired appearance, since they were the most likely designers. Four pilasters of the Tuscan order emphasize the façade and are capped by a shaped entablature. A pediment hugs the roofline. A window and very small Jesuit seal occur over the door. Brick pyramids emphasize the corners of the building. All these design features were commonly used on Jesuit churches of the period, churches that were often also decorated with carvings, religious statues and other elements. Given the sensitive political setting of early Maryland, however, use of such elaborate decorations on the outside of the building

would have been unwise. Therefore, efforts are being made to keep the classical influence while minimizing the decorative details.

The sides and back of the building will probably be finished with a red ochre color wash, a technique recent research reveals was widely used in the 17th century. Mortar seams will be penciled, or painted in, using a white lime mix. This technique added a look of precision and regularity to rough, handmade materials used in the 17th century.

The front, or west façade will be coated with a grey/white lime; a technique called rendering that was commonly used to give the illusion of stone construction. This rendering also will be applied around the windows to simulate stone, a treatment indicated for the chapel by the finding of specially molded window bricks.

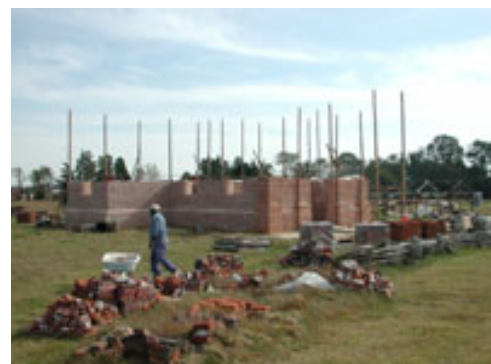
In September, the rising walls of the chapel began sprouting log appendages, the start of a pole scaffold that will surround and line the structure allowing workmen to reach roof and ceiling heights. The basic design of timber poles lashed together with ropes is derived from historical artwork. This type of scaffold was ubiquitous between 1200 and 1700 and is still used in some parts of the world today. It is almost certainly how the masons constructed the original chapel. Despite this important history, the

scaffolding is also being reinforced to meet OSHA standards for safety. Structural engineers have examined the scaffold plan and verified its strength.

Three levels of scaffolding allowed masons and carpenters to reach the highest points of the structure.

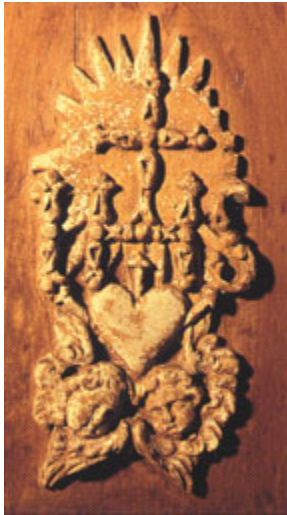
The tabernacle is the only intact interior piece of the chapel believed to exist today. Descendants of the Carroll family donated the wooden altarpiece to the Sisters of Mercy in Baltimore in 1859. Legend held that the Calvert family brought the tabernacle to St. Mary's City and it is likely the piece mentioned in Charles Carroll's 1720-estate inventory.

Director of Research Dr. Henry Miller has been leading reconstruction efforts. The Sisters of Mercy have graciously permitted researchers to measure and photograph the tabernacle. Dr. Miller has completed scale drawings of the tabernacle and will soon begin modifying those to incorporate current research describing what the piece may have looked like in the 17th century.

Dr. Harry Alden, of the Smithsonian Institution, was allowed to take samples of wood from the tabernacle. Alden has since determined the body of the piece is juniper, the elaborately carved trim is true mahogany, and the backboards, which are probably replacements, are magnolia.

Dr. Melvin Wachowiak analyzed the surface treatment and found an early coating of red paint, a later finish of white paint, and evidence of recent restoration. The carvings (top right) were also analyzed. A micrograph of a cross section of the carving (below) showed this element was treated with gesso, sealer, sizing, and gold leaf.

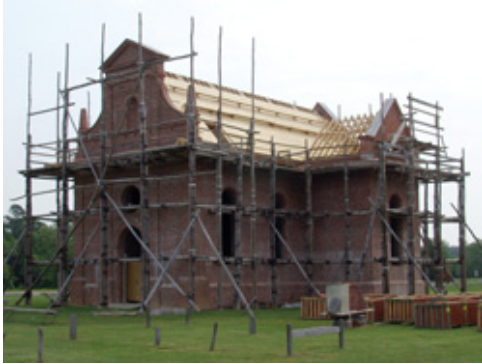
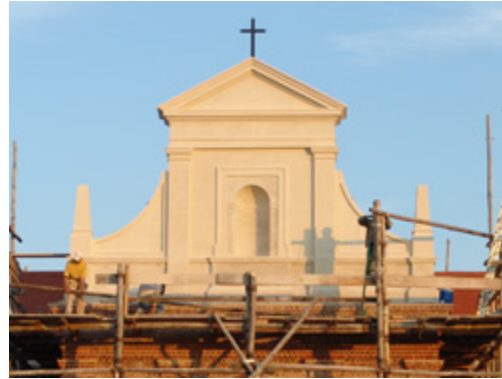
In March 2007, the roof for the chapel began with the installation of a rugged truss system that also supports the barrel vault. Blue Ridge Timber Frame of Swannanoa, N.C. designed and built the roof system. Each 15-piece truss interlocks to form the pitch of the roof and the curve of the vaulted ceiling without outward splay. When the components were delivered to HSMC, 699 pieces of southern yellow pine were assembled on the ground in a day. The seven main trusses were then flown into place using a

crane. Trusses for the transept followed. Roof construction will continue into the summer with the addition of 1 x 6 pine roofing boards, a leak membrane, and battens, which will ultimately be used to secure clay tiles. At the beginning of September, carpenters began to affix the clay roofing tiles. The last tile was placed mid-November, 2007.

In March 2007, carpenters began installation of the rugged truss system that also supports the barrel vault. Each 15-piece truss interlocks to form the pitch of the roof and the curve of the vaulted ceiling without outward splay.

When the components were delivered to HSMC, 699 pieces of southern yellow pine were assembled on the ground in a day. The seven main trusses were then flown into place using a crane. Trusses for the transept followed. Roof construction will continue into the summer with the addition of 1 x 6 pine roofing boards, a leak membrane, and battens, which will ultimately be used to secure clay tiles.
